CITY OF LOS ANGELES
DEPARTMENT OF PUBLIC WORKS
Bureau of Engineering
GEOTECHNICAL ENGINEERING DIVISION

Date: November 14, 2023
GED File No.: 23-222
C.D. No. 11

SUMMARY OF FIELD INVESTIGATION

Location: Via De Las Olas @ Friends Street
2005 Thomas Guide: Page 631-A6
Requested By: Kevin Patton, RAP
In Attendance: Lisa Gerencher (Geotechnical Engineering Division), Richard Thompson, Arthur Rodriguez, Steven Hamilton (LAFD)
Date of Investigation: August 30, 2023

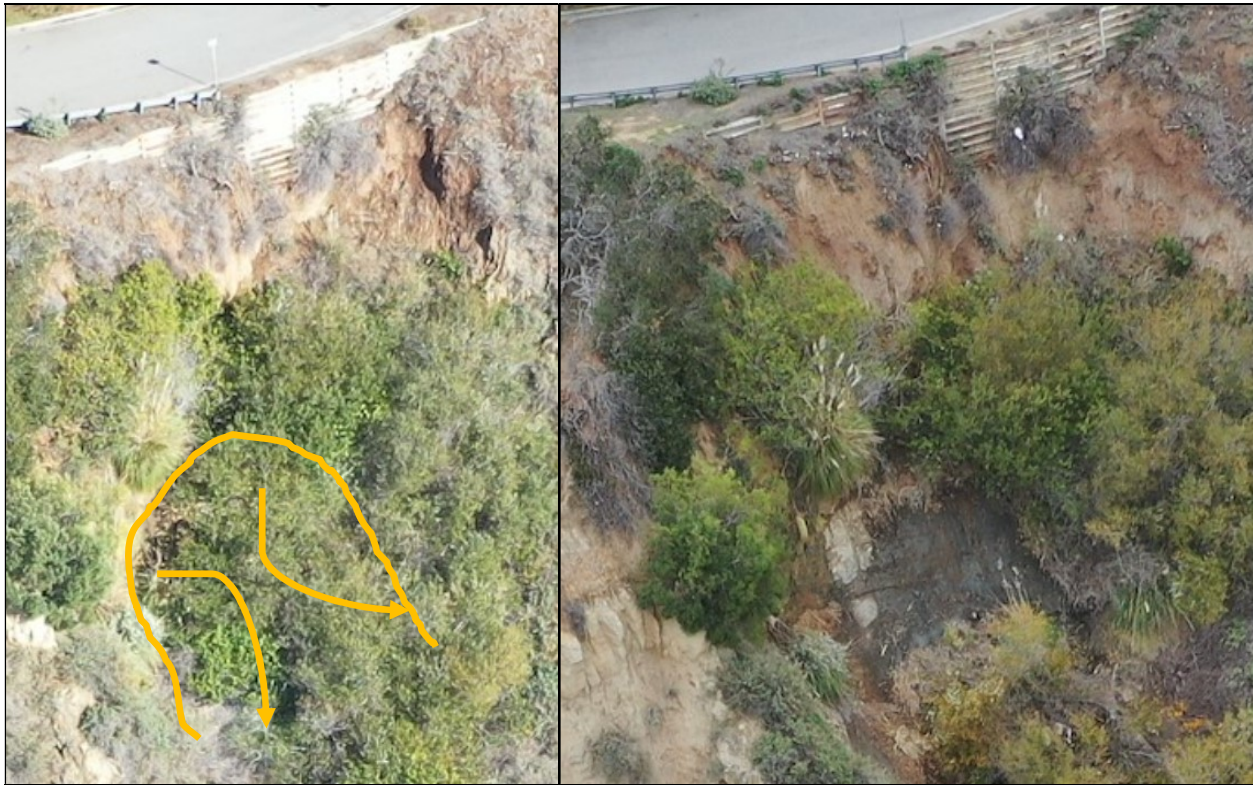
In early January 2022, a 40-foot wide by 150-foot-long section of this fill-buttress slope along with terrace drains collapsed in a surficial landslide onto the Potrero Canyon Access Road below the existing bulkhead. As shown in Photo 1, based on aerial photographs from December 2021 (before the slide occurred) and January 2022 (following the slide), the landslide occurred at the geologic contact between QoAl and the Fernando Formation. Subsequently, the material that slid in 2022 was reactivated due to the heavy rains in early 2023 and again came down onto the Potrero Canyon Access Road.

Photo 1: Photo on the left is of December 2021 before the slide occurred, and photo on the right is from January 2022 following the slide. The yellow outline illustrates the approximate limits of the slide on the before picture.

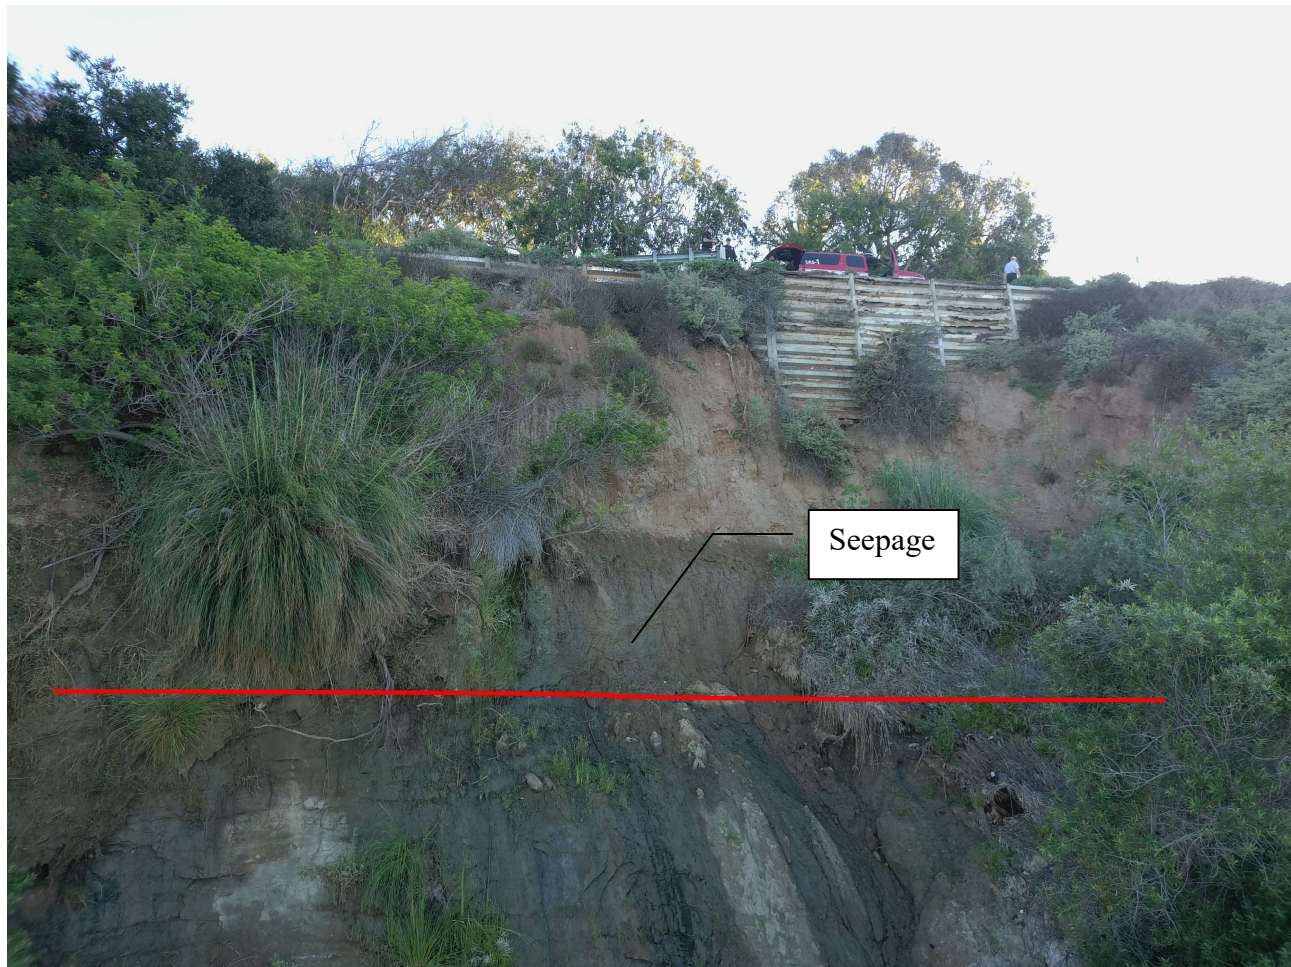
Photo 2: An August 30, 2023 LAFD aerial drone image shows a closer image of the head scarp of the slide. The geologic contact is outlined in red. Groundwater which has reached the surface emanates as a spring, where the alluvial terrace overlies the less permeable siltstone Fernando formation below.

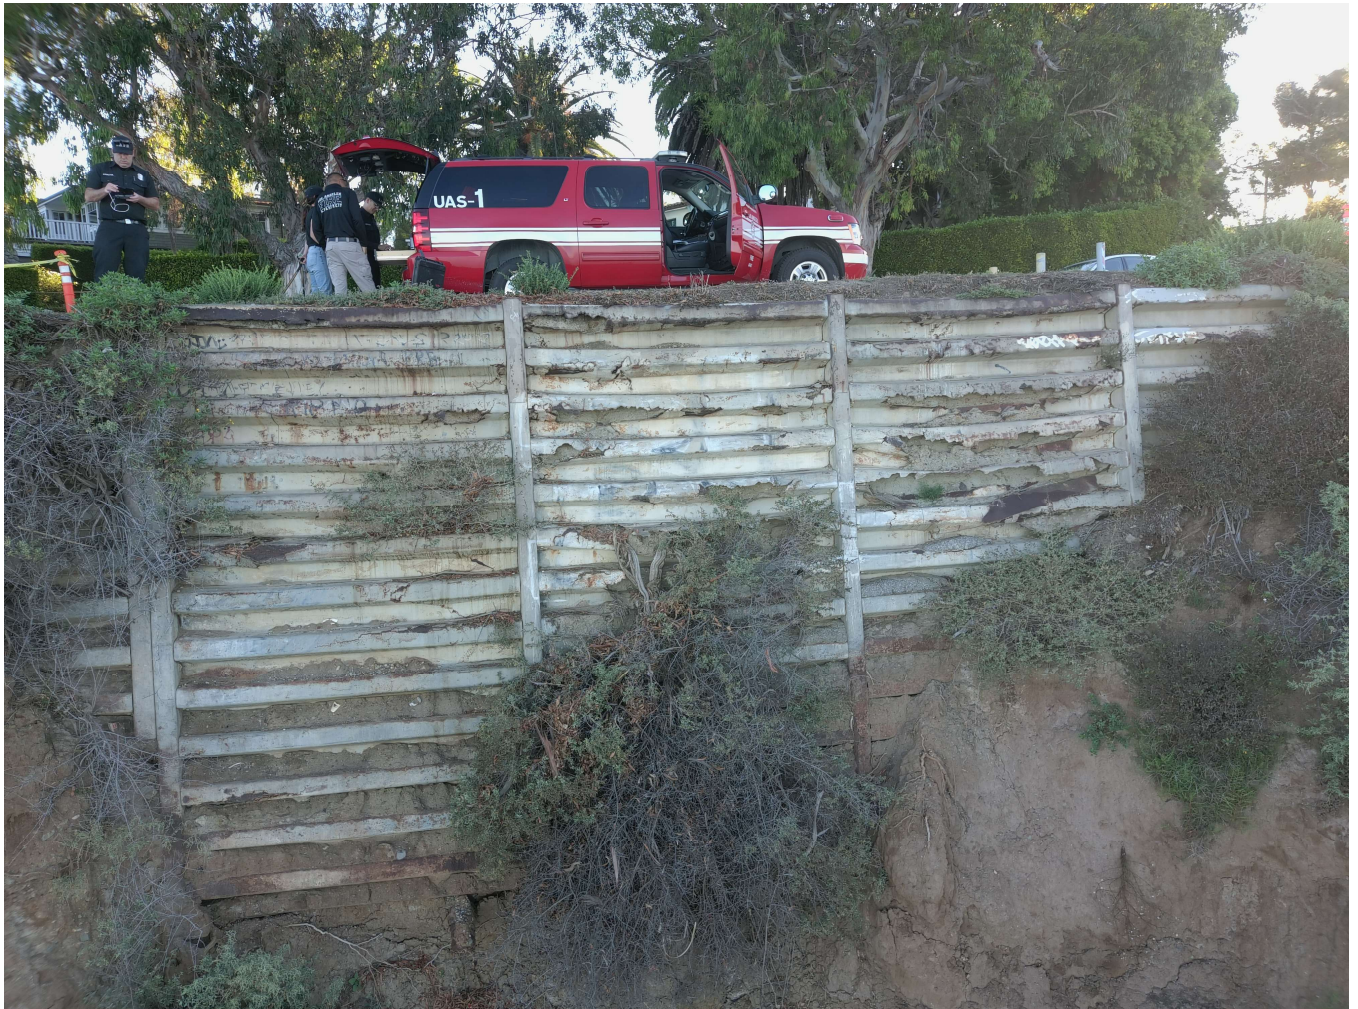
Photo 3 shows the deteriorated state of the ribbed-metal bulkhead. The soil in front of the bulkhead looks to have sloughed away, the date of which this occurred is unknown, and the base of the bulkhead looks to be slightly undermined. The bulkhead also has vegetation roots that have broken through the corroded face of the bulkhead.

The bluffs form an eroding cliff with the downslope component facing the sea with a history of constant erosion and landslides. The bluffs by their nature being composed of sandy and gravelly material are highly transmissive of subsurface water which moves through the formation and ultimately discharges to the slope face where the QoAI meets the less permeable silty-claystone Fernando Formation below it. It does not appear likely that the water emanating from the slope face is a result leaking storm water infrastructure. From previous review of available literature concerning the area and the seepage, GED feels that the seepage emanating from the slope face is a combination of groundwater and urban recharge on the mesa, the majority of which likely comes from irrigation water that seeps into the subsurface and ultimately discharges at the slope face as a contact spring. Considering the lithology of the subsurface, the dip of the bedrock formation, and the constant water seepage, the slope beneath the existing bulkhead is susceptible to further movement and erosion which will cause the undermining of the bulkhead to continue.

Photo 3: The deteriorated state of the ribbed-metal bulkhead. The soil in front of the bulkhead looks to have sloughed off, the date of which it occurred is unknown, and the base of the bulkhead looks to be slightly undermined. The bulkhead also has roots that have broken through the corroded face of the bulkhead.

The orientation of the Fernando formation shows to be dipping out-of-slope, unfavorable to gross slope stability. While a section of slope below the in-situ bulkhead may be susceptible to further slope movement, the Via de Las Olas/Friends Street roadway above appears to be in good condition and shows no signs of distress. While the in-situ ribbed-metal bulkhead does appear to be stable, it is in an ever-deteriorating condition. GED is referring the bulkhead issue to the Hillside Slope Stability Program for ranking as a possible Capitol Improvement Project.

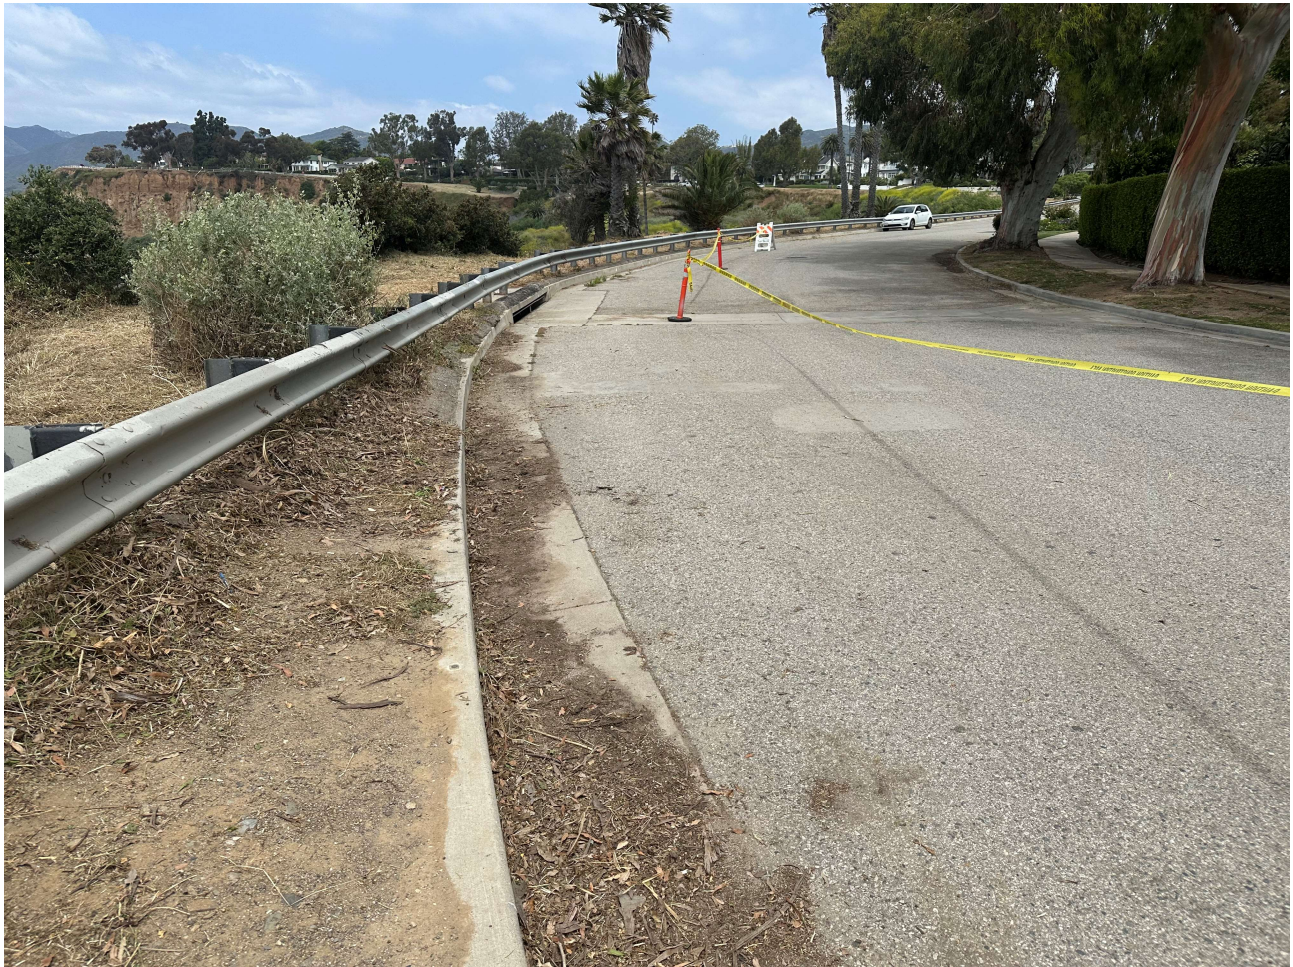
As shown by Photo 4, no tension cracks were observed to be affecting the Via de Las Olas/Friends Street roadway above. In addition, the storm drain system and the northern end of the in-place bulkhead does not show any signs of damage or water buildup. The storm drain inlet appears to be dry while the seepage at the slope face below the bulkhead is continuous.

Photo 4: No tension cracks are observed to be affecting on the street, and the storm drain system and the northern end of the in-place bulkhead does not show any signs of damage or water buildup. As the drain appears dry, it does not appear likely that the water emanating on the slope is a result of a leaking storm drainpipe.
